Safety Alert to IWEA members.

Blade contact with crane during installation.

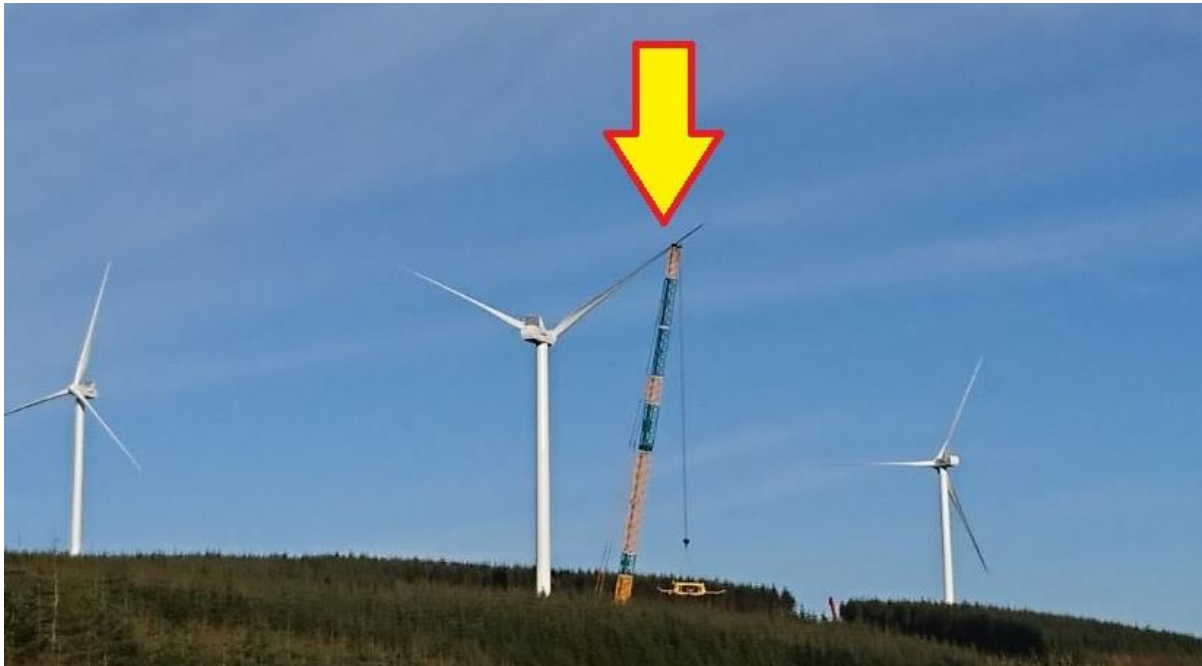
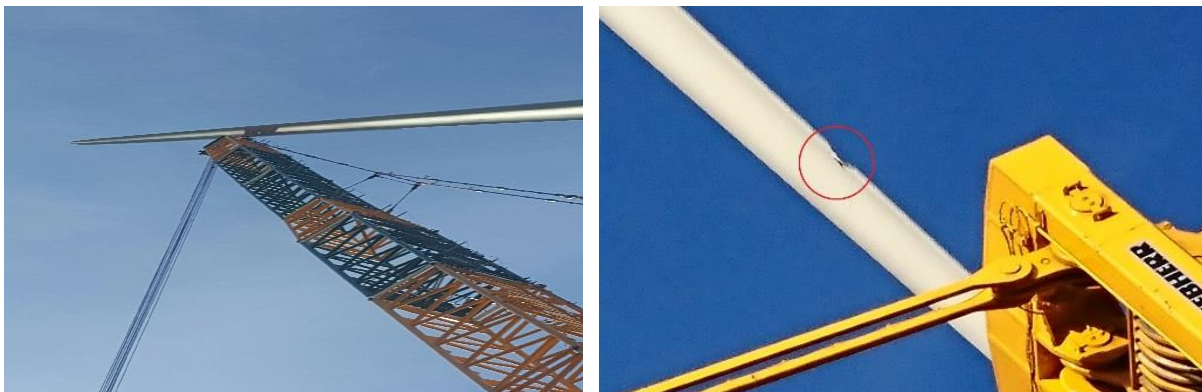
A wind turbine blade made contact with the jib of crane during turbine erection. There was nobody injured in this incident. The incident resulted in minor damage to crane components and the blade.

Two blades were installed. The crane was stationary in position over the blade fingers to sling the last blade. While the nacelle and hub were being moved into position to receive the last blade, one of the installed blades made contact with the crane jib. Mechanical failure is not thought to be a cause in this incident.

This incident reminds us all of the importance of clear control of work and good communication between all persons and work groups on the hardstand.
